CENTAUR AC-4 NOSE FAIRING JETTISON TESTS

by Jack C. Humphrey
Lewis Research Center
Cleveland, Ohio

Abstract

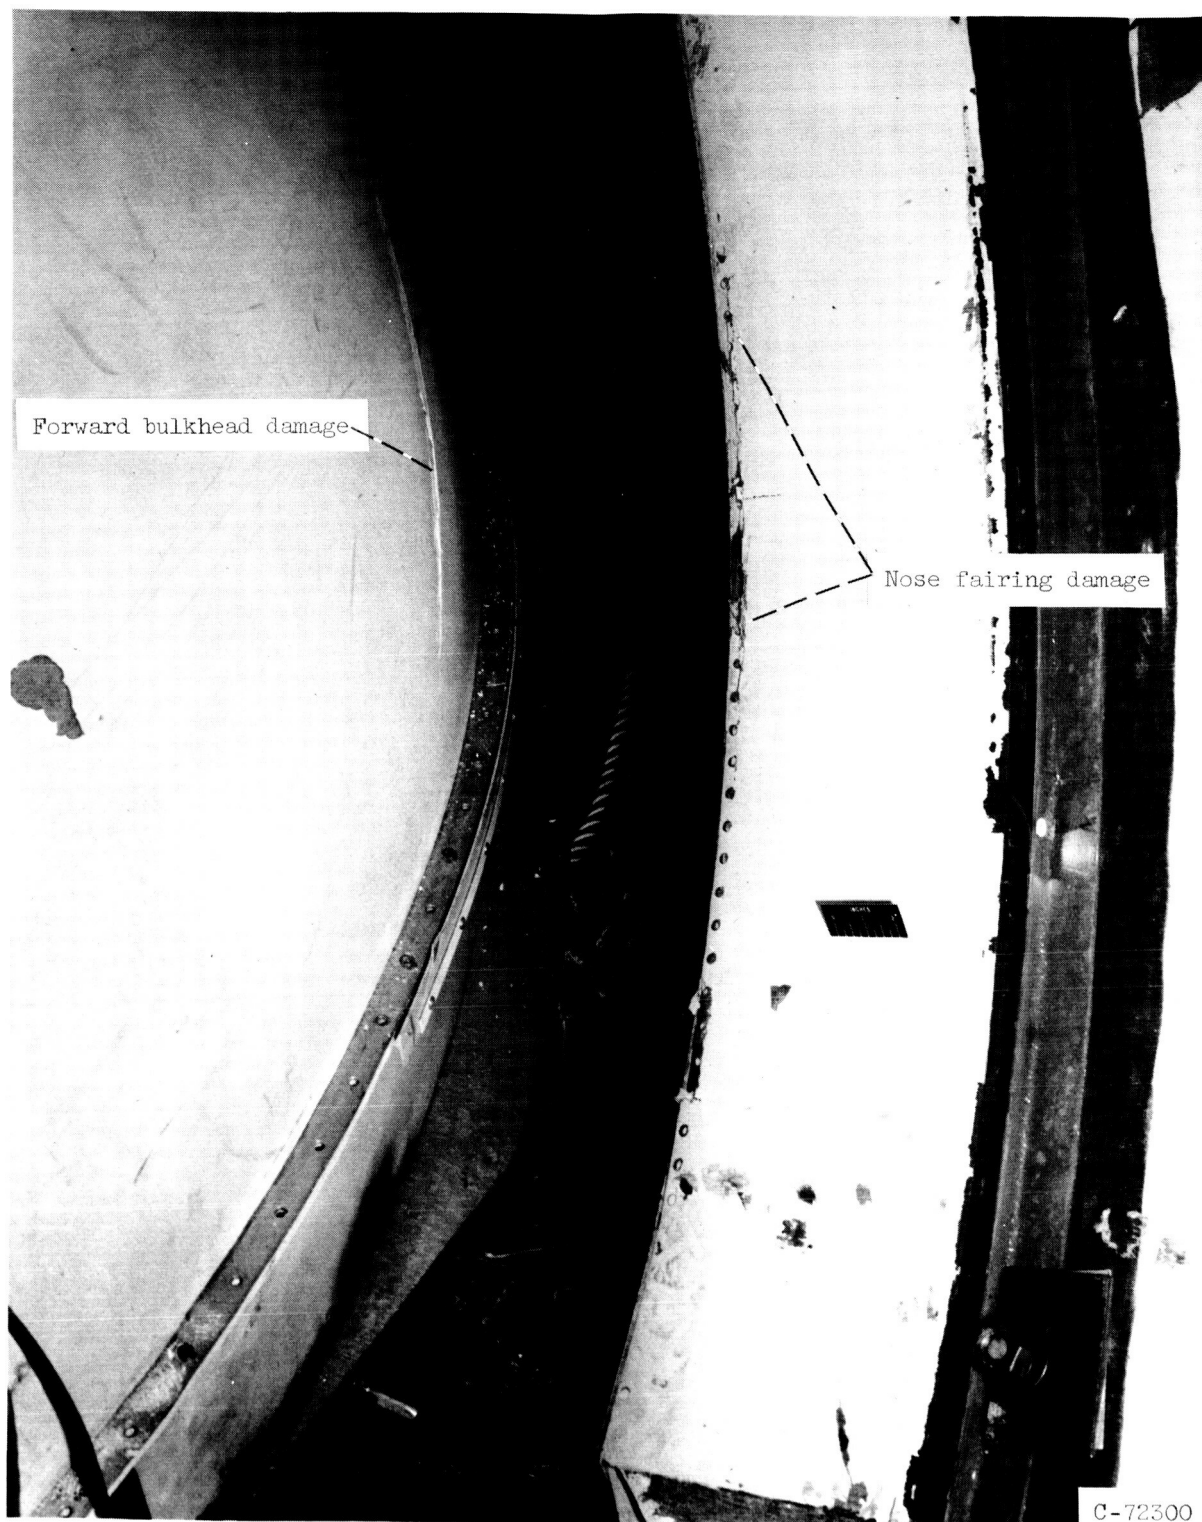
Figure 24. - Damage to forward bulkhead and to barrel section. Test 6.

Although nose cone separation was accomplished without damage to the fairings and the newly added deflector and thermal bulkheads, damage was done to the fairing halves by the facility. The trajectory of the II-III half was such that the top of the fairing contacted the tether rope take up mechanism and the barrel section of the same half rebounded after hitting the net and hit the Centaur forward bulkhead model. Figure 24 shows the damage to the II-III half forward bulkhead and the barrel section. It can be seen that the interior of the barrel section was crushed in the 219 ring area. Damage was also done to the I-IV cone in the area of attachment of the ratches rods used to prevent rebounding after contact is made with the catcher pad. It was noticed after the test that one of the ratchet rods was badly bent probably as a result of the rod striking some fixed part of the deaccelerating box. Figure 25(a) through (e) shows the raw data and figure 26(a) through (c) shows trajectory plots.

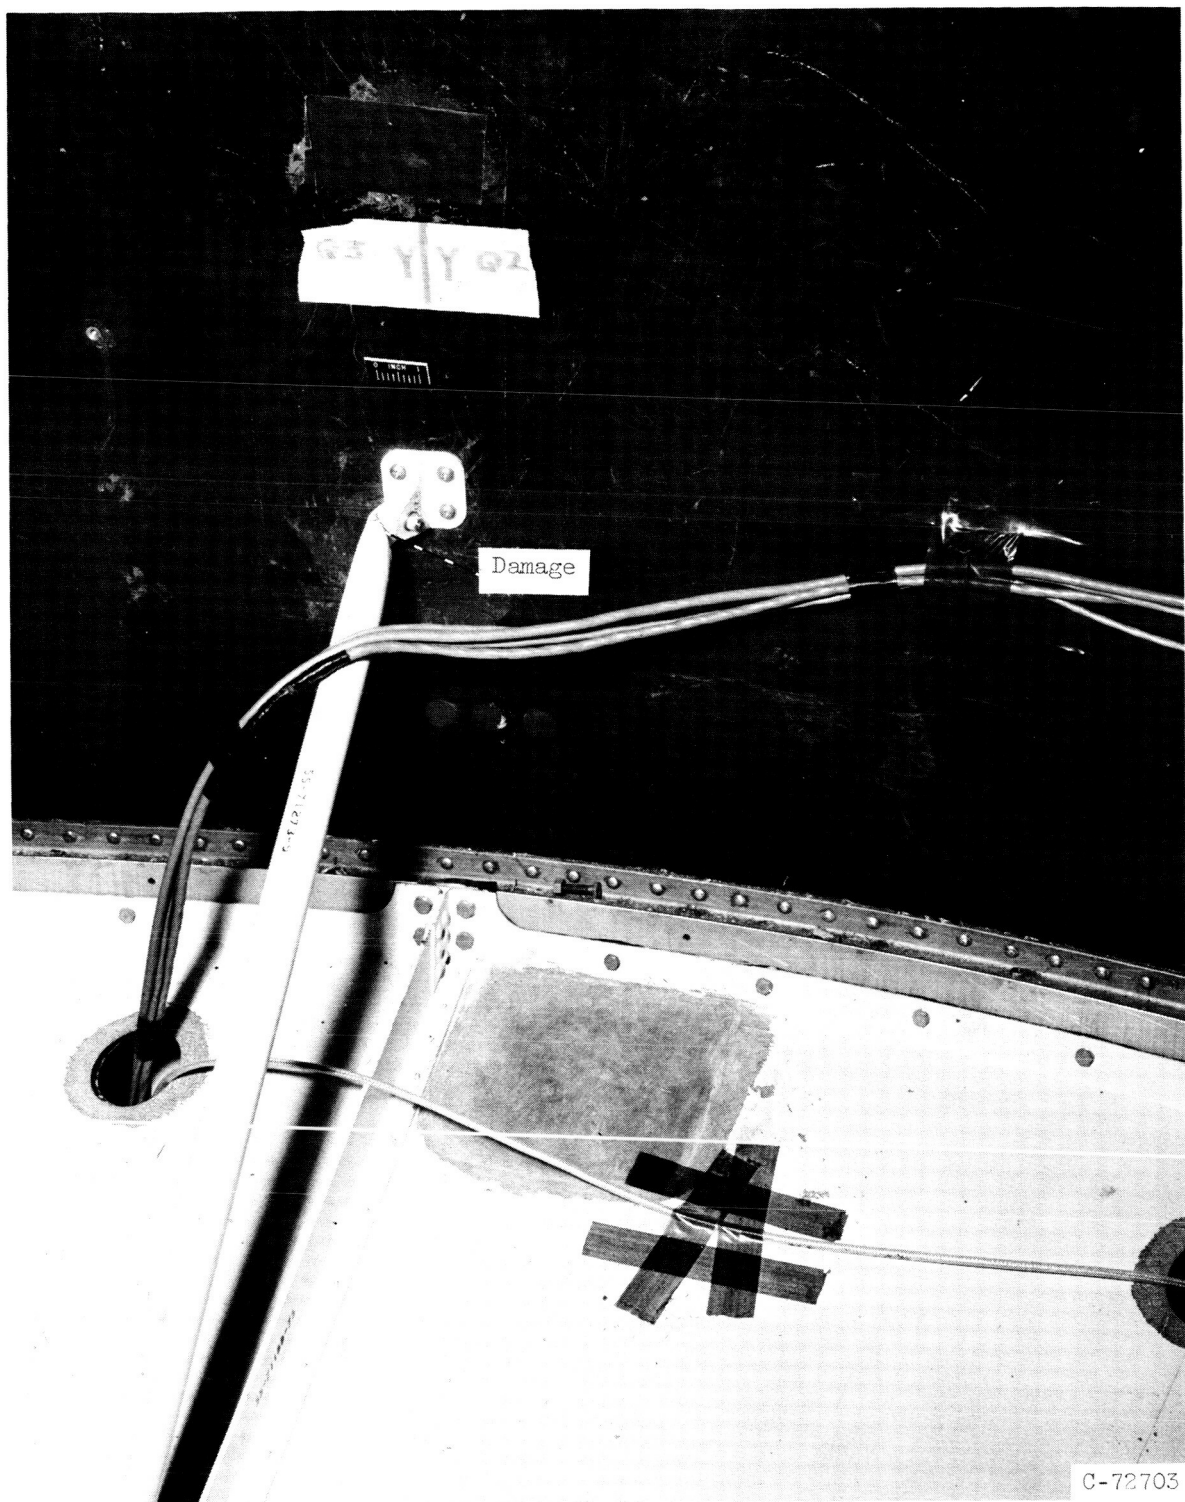
Figure 31. - Strut located on YY axis of II-III half of fairing during Test 8.

Examination of the fairing after the test revealed that two thermal bulkhead struts suffered compressive type failures and one of the aforementioned strut brackets was damaged. These failures were caused by the dynamic forces during jettison and not by collision with deaccelerating devices. Figure 31 shows one of the damaged struts located at the YY axis in the II-III half of the fairing. Also in this test the air conditioning duct which is attached to the thermal bulkhead by an adhesive was torn loose. Figure 32 shows this damage. Motion pictures again revealed that the I-IV fairing half rebounded off the net and hit the Centaur forward bulkhead but in this case no damage occurred on the fairing. Figures 33(a) through (i) show the raw data obtained from this test and figures 34(a) through (c) show the trajectory.

Repair of the air conditioning duct damaged in test 8 was made by use of bolts which passed completely through the thermal bulkhead and the duct flange; the damaged struts were replaced by new ones.

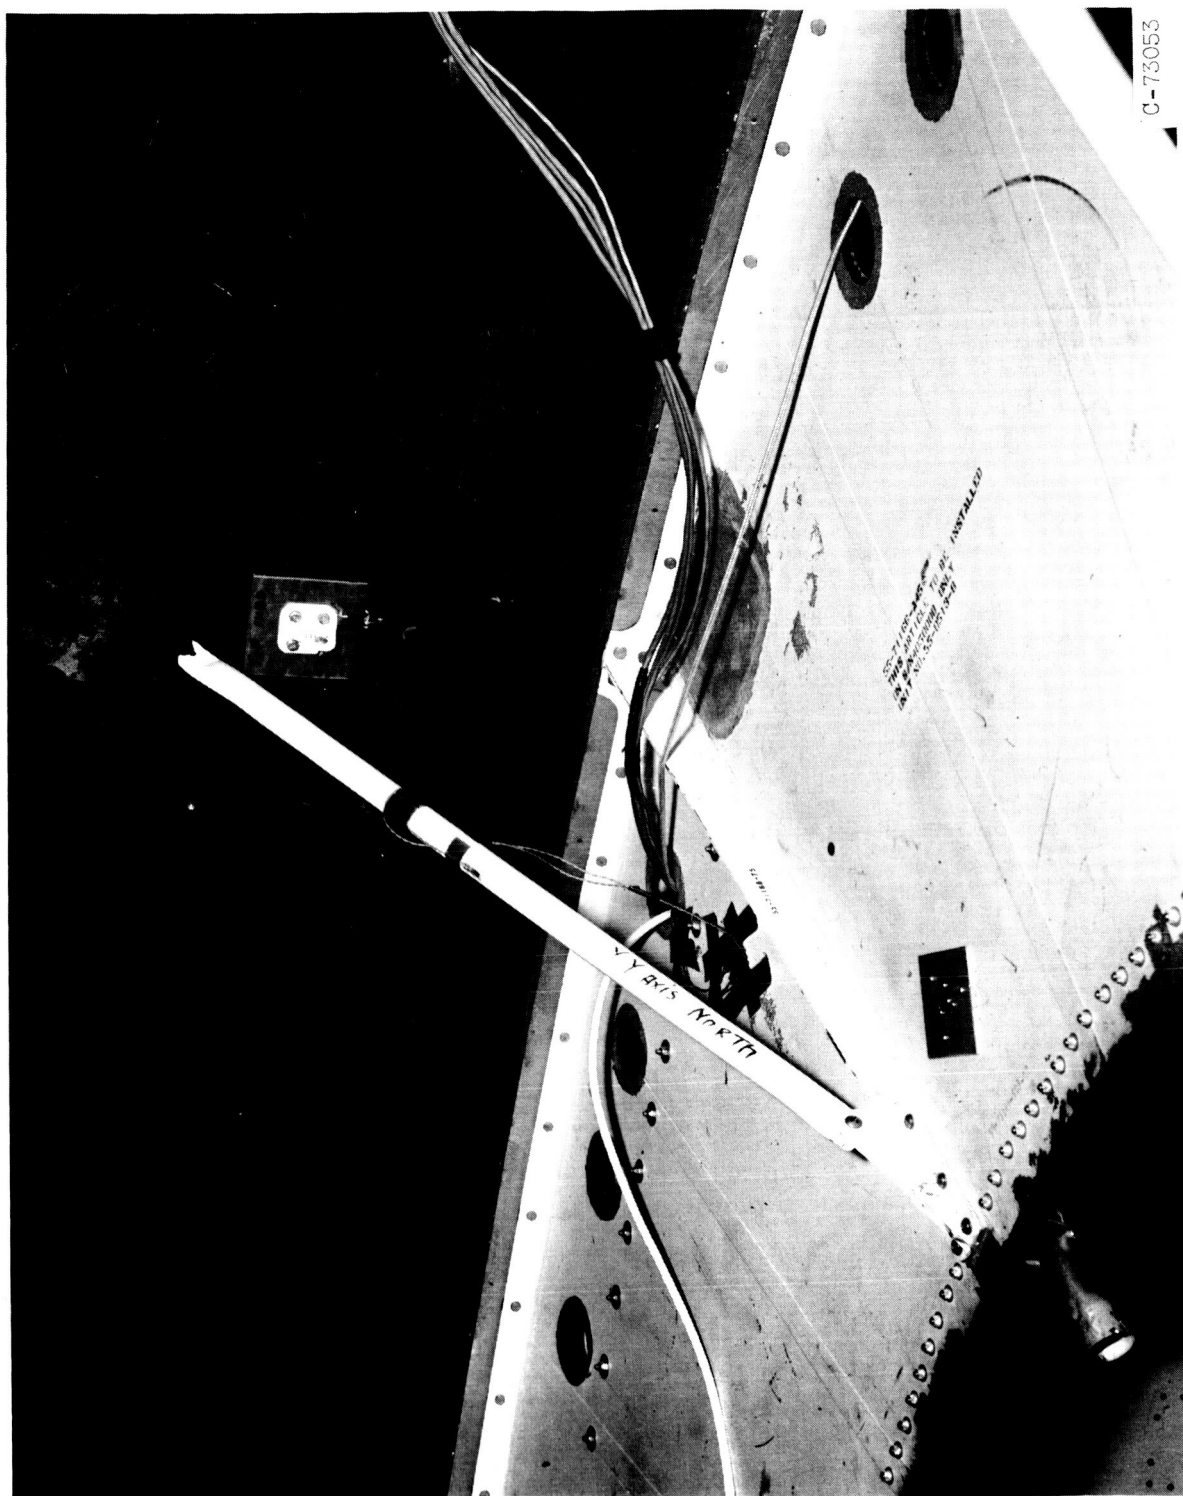
Figure 44. - Strut damage, Test 11.

For this test a successful jettison was obtained with the only damage on the fairing being limited to one strut on the II-III fairing half at the YY axis. Figure 44 shows this damage. Movies taken during the separation clearly show that this failure was caused by vibration of the thermal bulkhead during separation and not upon collision of the fairing with the catcher pad.

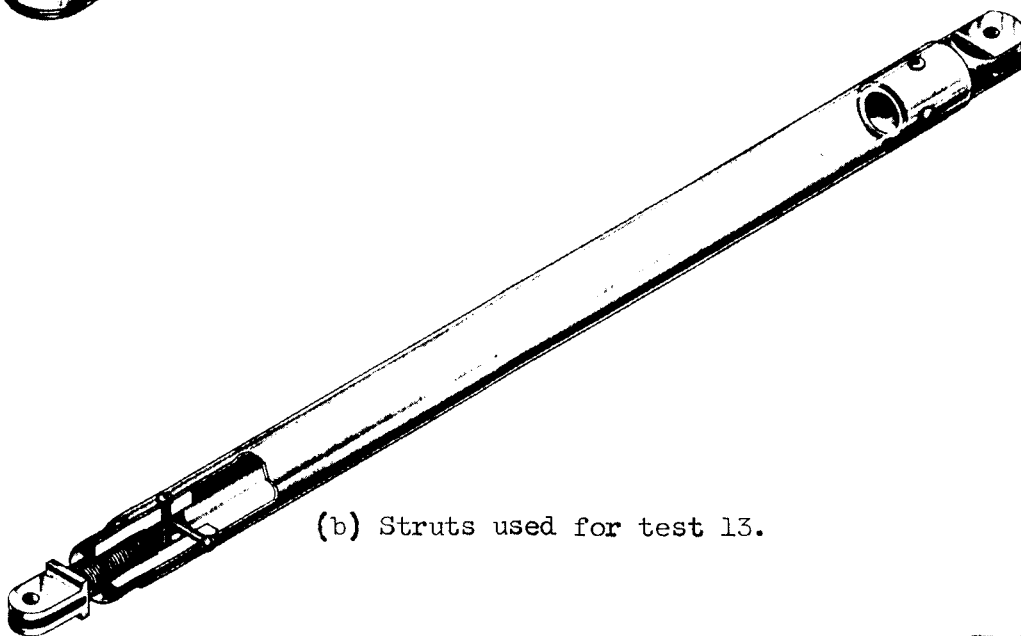
Figure 50. - Thermal bulkhead strut.

As a result of the failures the struts were redesigned and the new design was used in test 13. The strut before and after redesign is shown in figure 50. One failure of the redesigned struts (the number 3 strut) did occur by bending in test 13 as shown in figure 60. This failure occurred however after contact with the facility catcher and would not occur on a flight separation of the fairing. No damage occurred at the previous failure point, the attachment of the strut to the fairing bracket, in test 13.

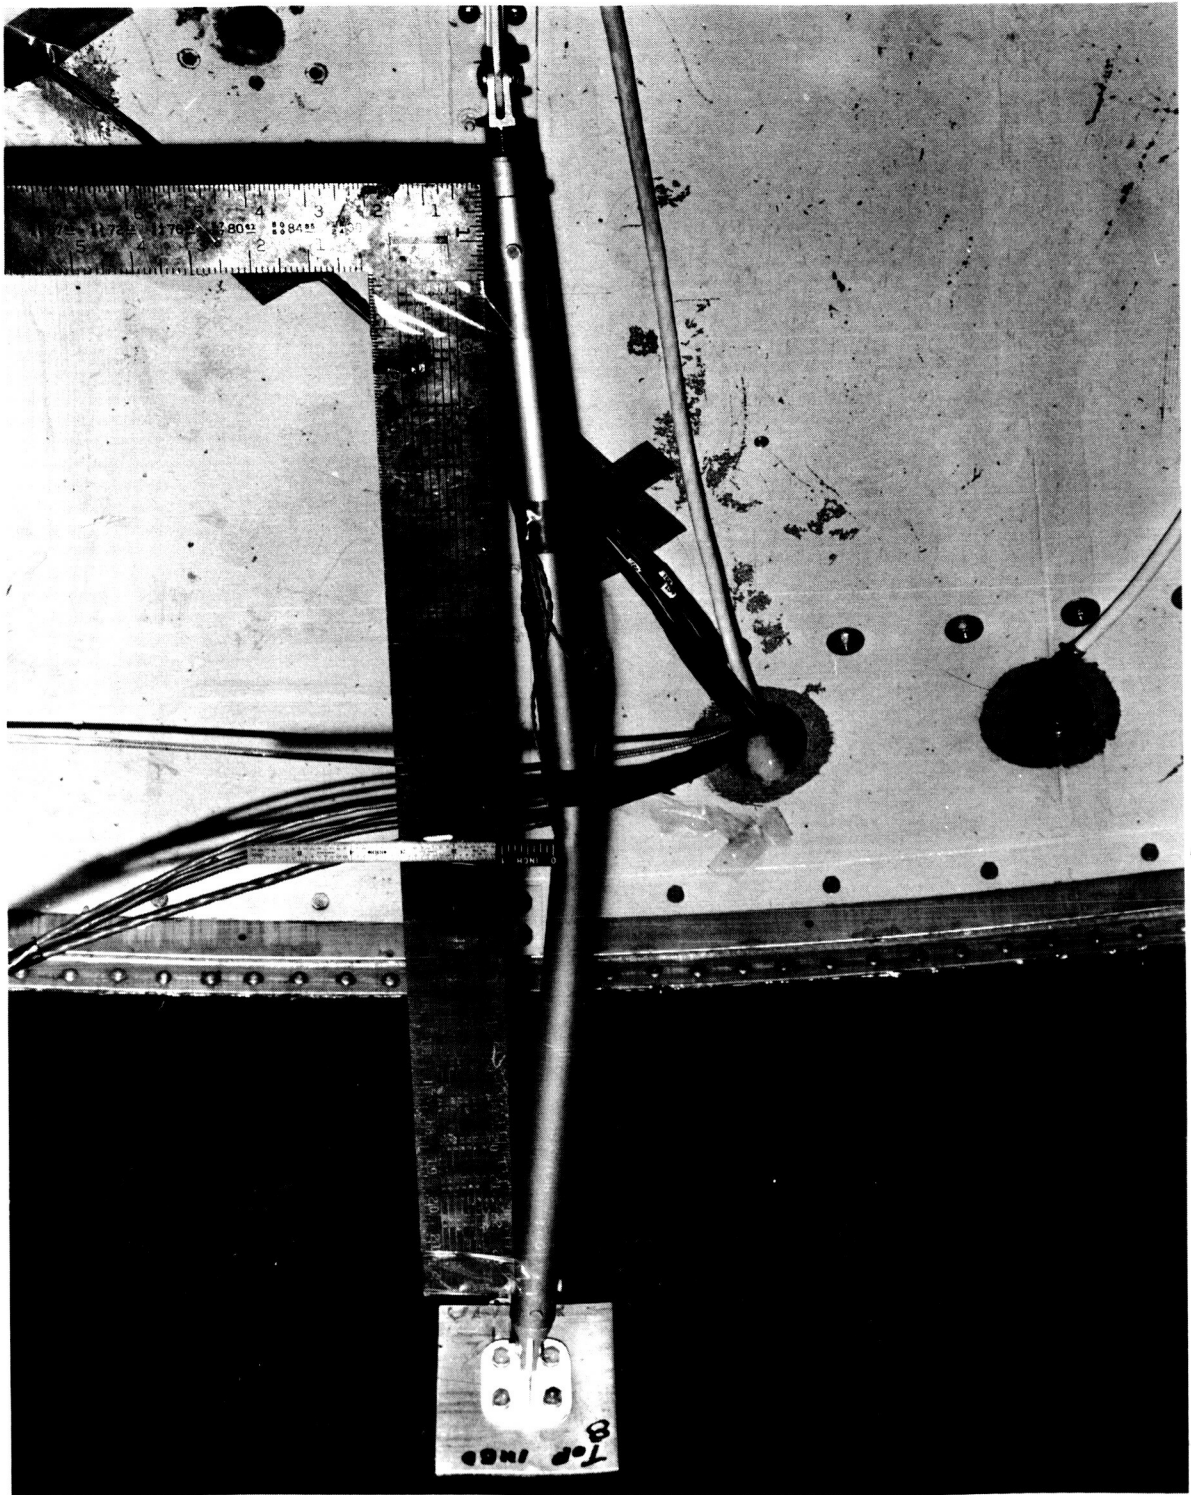
Figure 60. - Damaged strut Test 13.

Separation was successfully accomplished. One strut was bent as shown in figure 60. Examination of data revealed this damage occurred after fairing contacted the catcher plate. Toothpicks on both the Guidance Platform mount and the A/P programmer were broken but the remaining shorter toothpicks showed that sufficient clearance existed between the bulkhead and the packages. Minimum clearance as shown by toothpicks was 0.3. Figure 61 and 62 show the toothpicks, that were undamaged. Figure 63(a) through (f) shows the raw data and figure 64(a) through (c) show the trajectory.
